Malvern Hills AONB Partnership  
**Three Counties Showground, Malvern**

# Preliminary Landscape Assessment and Recommendations

November 2011

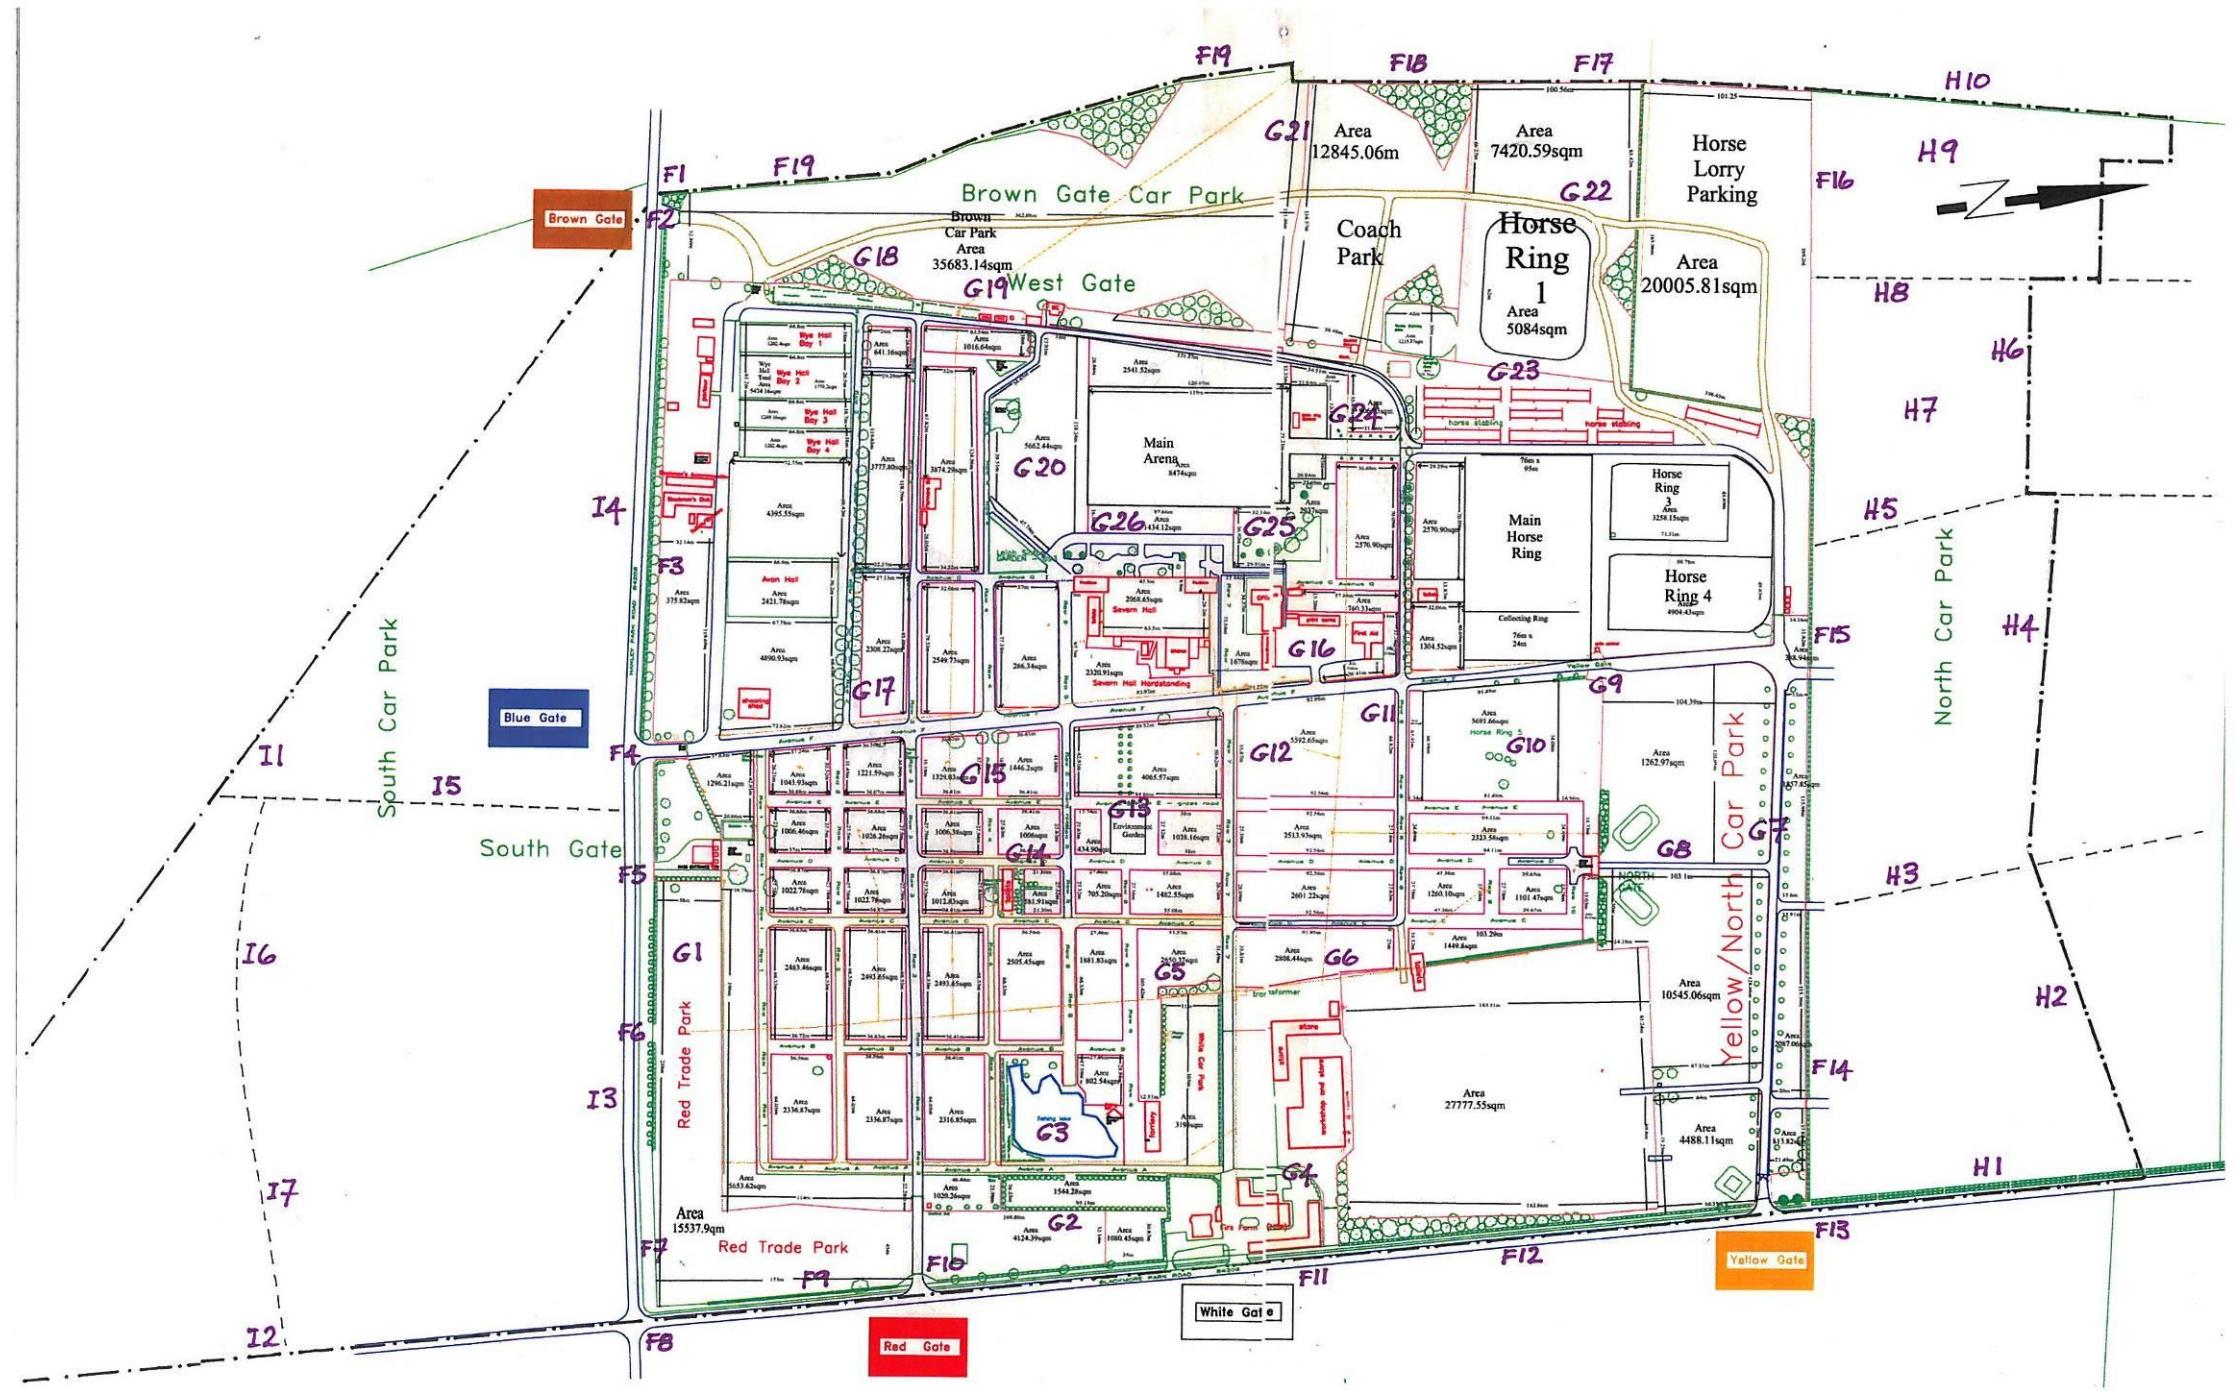
## PLAN TO ACCOMPANY REPORT

The following location-specific recommendations are preliminary suggestions for short, medium and long-term landscape and environmental works based on a rapid assessment of the existing situation on the ground. These should be revised following more in-depth and detailed surveys, studies and strategies as set out above. The numbering should be read with reference to plan attached at the end of this report.
